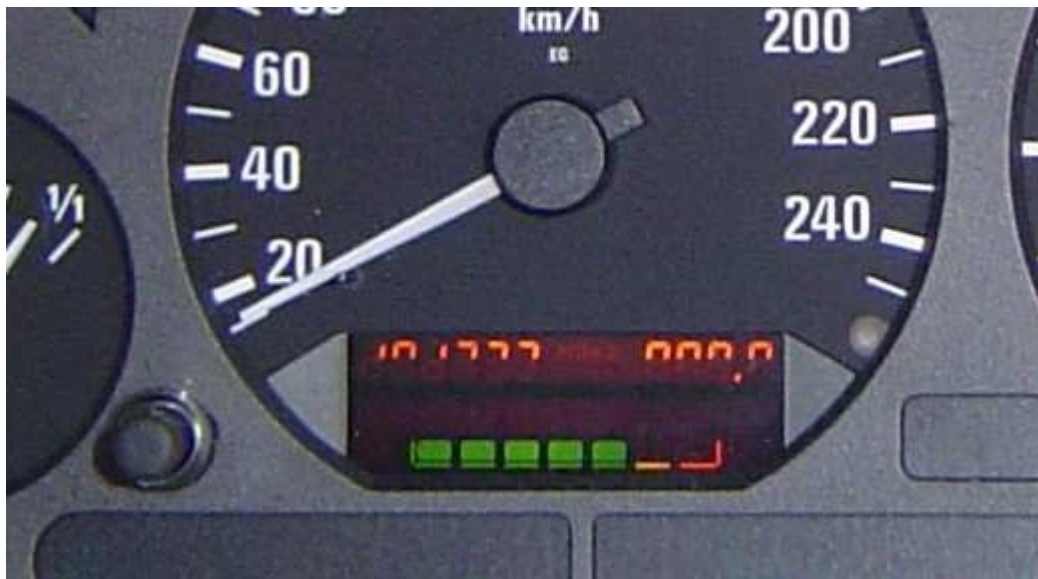
This is the problem – only the top half of the odometer and trip meter is displayed. It is a backlit LCD device but the two bulbs illuminate the odometer and service indicator respectively.

Since only the top half of the odometer is displayed the problem is obviously with the LCD and not the bulbs. Commonly this is an intermittent but annoying problem.

I used a hot pencil tipped soldering iron to reflow all of the SI board pins, then carefully replaced the cut cover section using 5 minute epoxy. Apply the epoxy carefully to the cut edges of the housing. Then once its back in place use a rag soaked with turpentine to remove the excess.

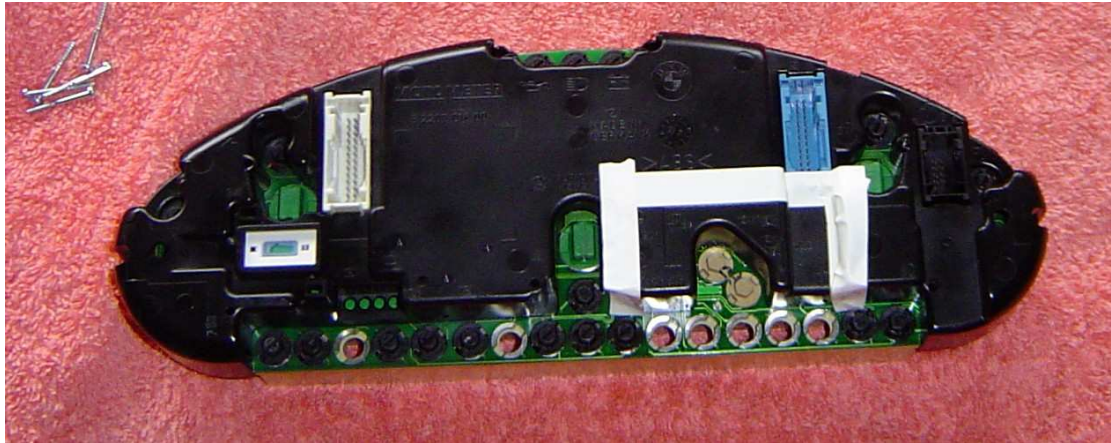
There is a fair bit of clearance between the cover and the board but I would suggest extreme caution as you cut down the side of the housing toward the board as there are a couple of tracks that run across the board at this point and a slip here could cause big problems.

Mark out the area of interest – I used white tape and then cut carefully with a piece of hacksaw blade. You could use a Dremel or even a hobby knife heated with a torch for this job.

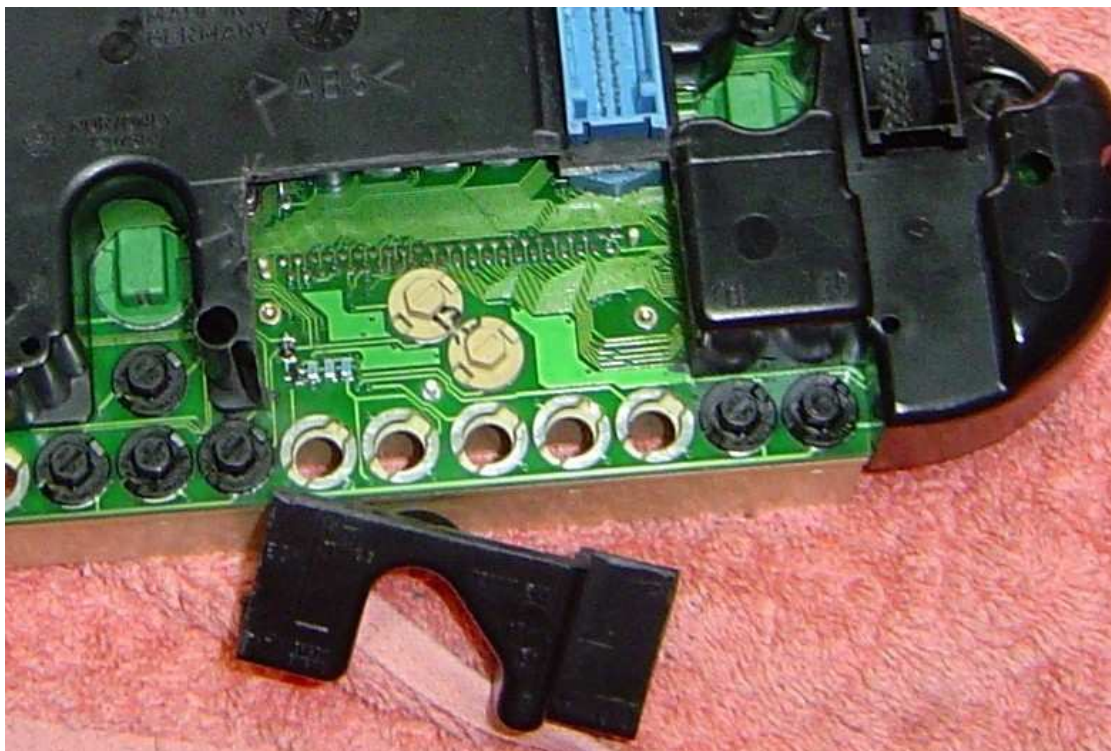
Notice that there are also couple of little gold coloured torx screws which secure the SI LCD to the board. Check that they are snug but do not overtighten them. The idea is to make sure that all the electrical connections are firm, not to cause fractures in the board by overtightening the components.

I worked carefully and completed the cut within about half an hour using a hacksaw blade – my modelling saw would have made life much easier if only I could remember what I did with it.

After removing the cut section carefully dress the edges of the cut area with a small file to remove burrs, then use a small paint brush and low pressure compressed air to clean the debris from the board.
