This Service Information bulletin supersedes SI B24 08 06 **dated March 2010**.

ZF 6HP Transmissions - Mechatronic Sealing Sleeve Seepage

NEW E53, E60, E61, E63, E64, E65, E66, E85, E90, E91, E92, and E93 vehicles with ZF 6-speed 6HP19/21 or 6HP26/28 transmissions produced up to 04/08

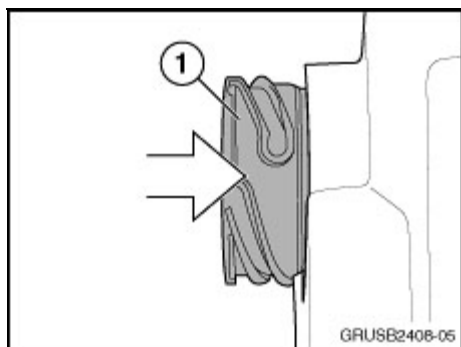
Transmission fluid seepage is visible in the area of the transmission oil pan. In most cases, only an oil "wetness" spot is spotted in the back of the transmission oil pan (the transmission fluid does not drop on the ground).

NEW 1. Only if a visible leakage trace indicates a substantial loss of transmission fluid (e.g., transmission fluid accumulation on the underbody panel), replace the Mechatronic sealing sleeve.

NEW The "oil wetness" in the area of the sealing sleeve is not an indication of substantial leak, and does not justify this repair.

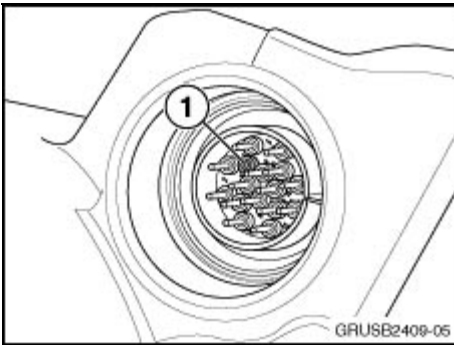
5. In some cases, the incorrectly installed sealing sleeve may permanently damage pins in the Mechatronic connector (X8500). In such a case, the Mechatronic module has to be replaced (**pin repair is not possible**).

The illustration shows an example of a broken and missing pin #4 in the X8500, caused by improper sleeve installation; this resulted in the customer's complaint about the inoperative Sport Mode of the transmission.
