BMW 5-series E61 Rear Glass micro switch replacement process

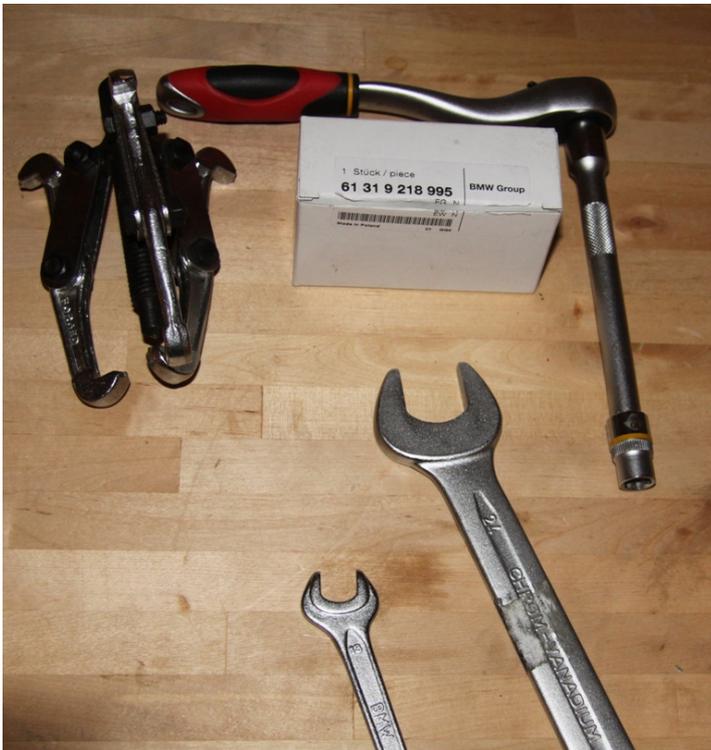
Ball bearing puller, socket wrench size 10mm, open-ended wrench/spanners size 13mm and 24mm, a knife or very fine screwdriver (not pictured) and the crucial spare part 61319218995 "rear window key button with micro switch".

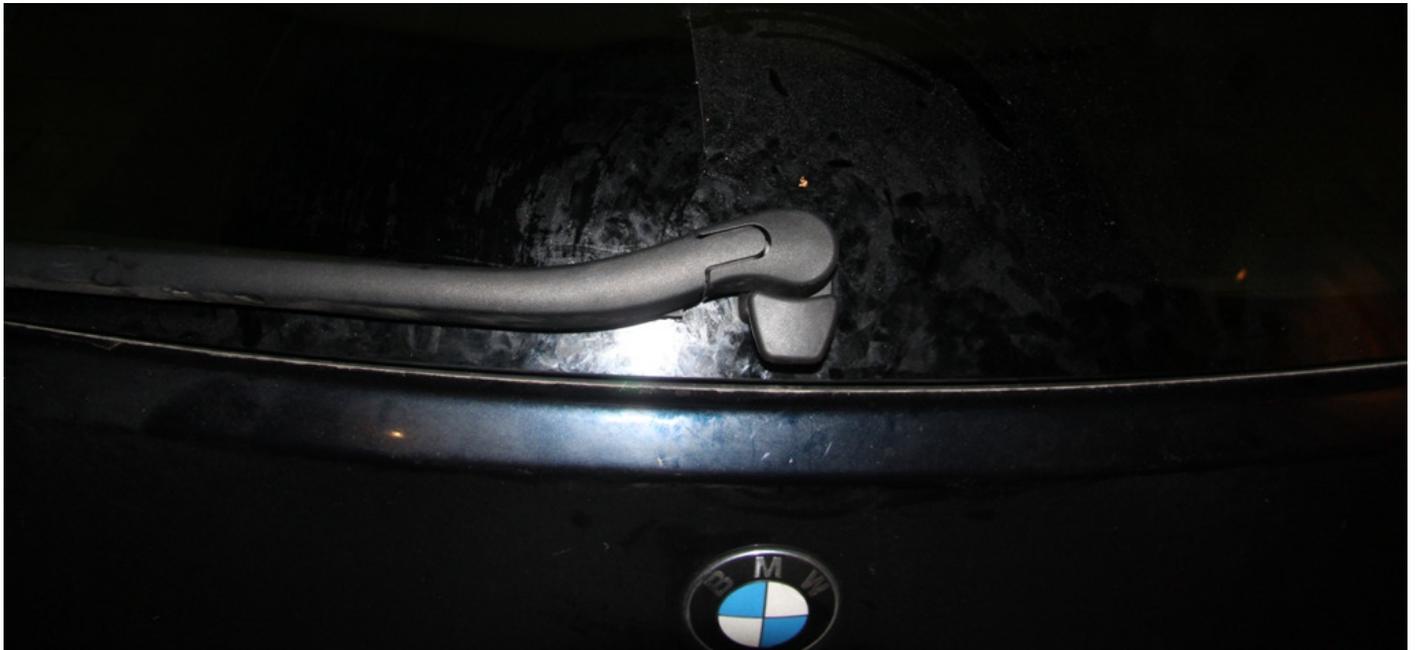
With the tools ready, here's where you start. Be sure the rear glass is open, so you can access it from the inside as well. If you have no way of doing this, you are SOL.... Well, you may be able to remove the inside cover in the hatch and get to the glass cover that way; not sure but there is a description elsewhere in the forum on how to possibly open the glass if you have lost all manual control over it and the car doesn't voluntarily open it for you...

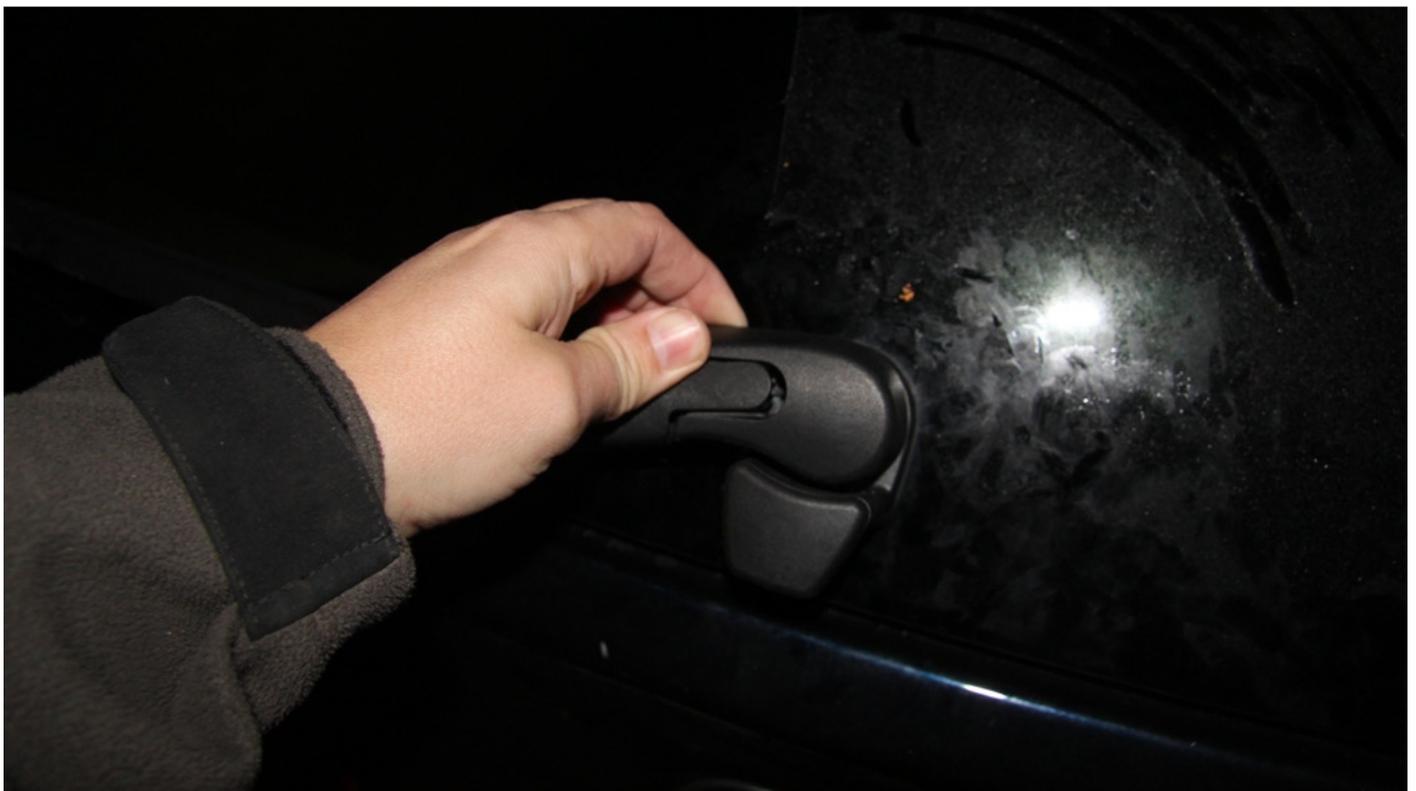
First, simply use your fingers to pry open the soft cover at the end of the wiper; it slides off without effort:

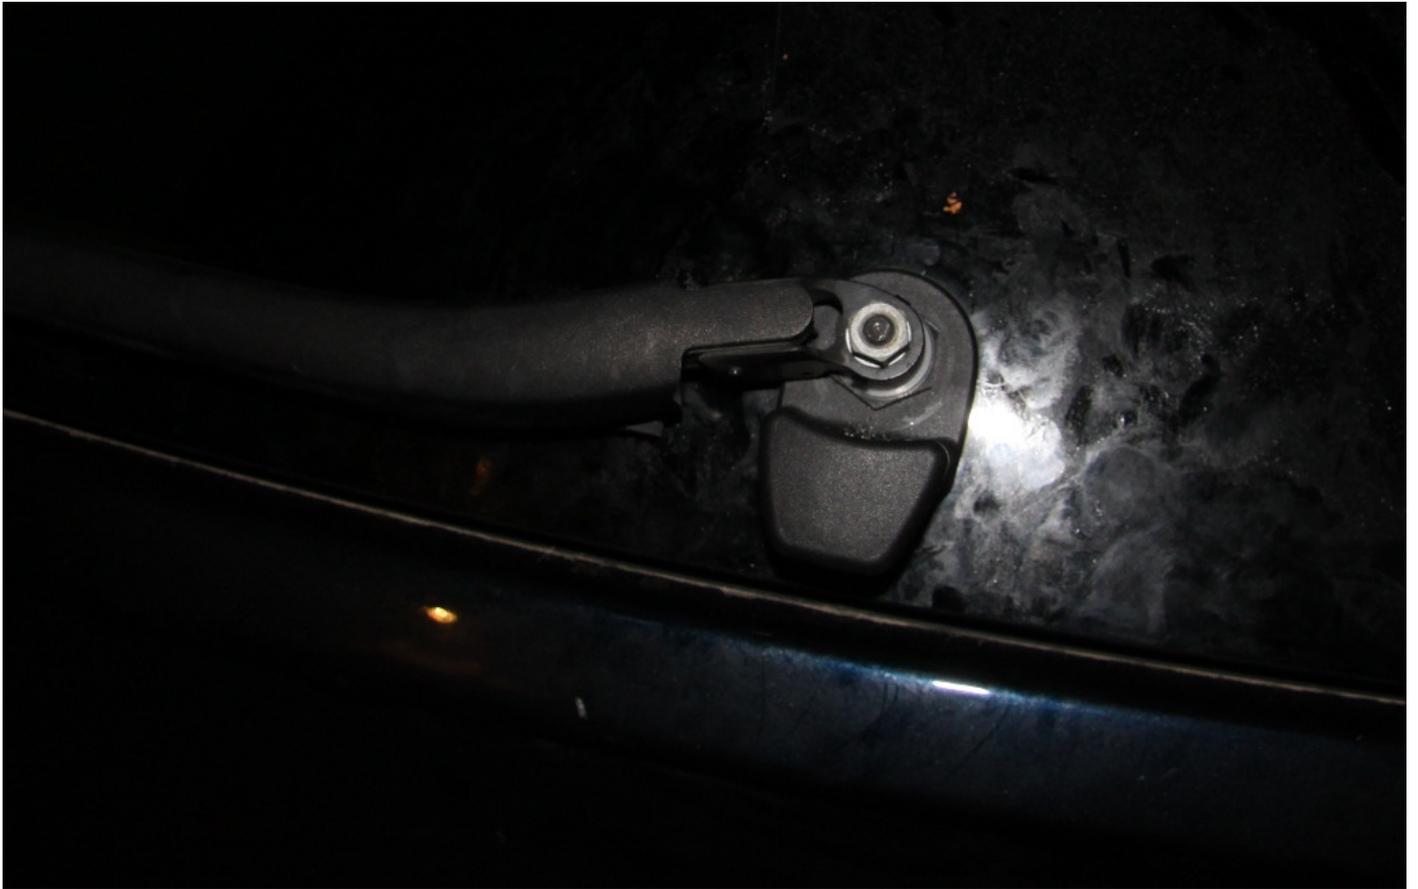
Now you will have access to the 13mm nut and washer which you unscrew using the 13mm spanner/wrench – there's one such in your standard BMW tool kit:

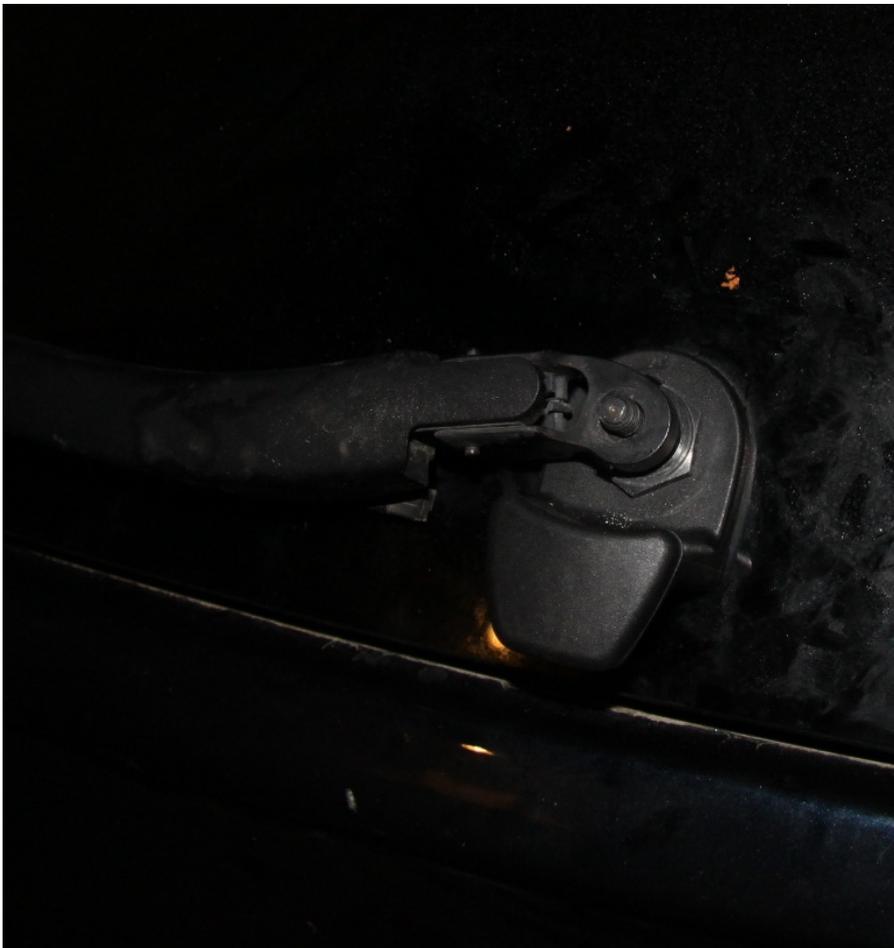
The picture here shows the wiper after unscrewing – not profound, but unfortunately I forgot to take a picture of the 24mm nut which sits beneath the wiper so I include the picture here anyway. After you've pulled the wire off the axle, you remove the 24mm nut shown here

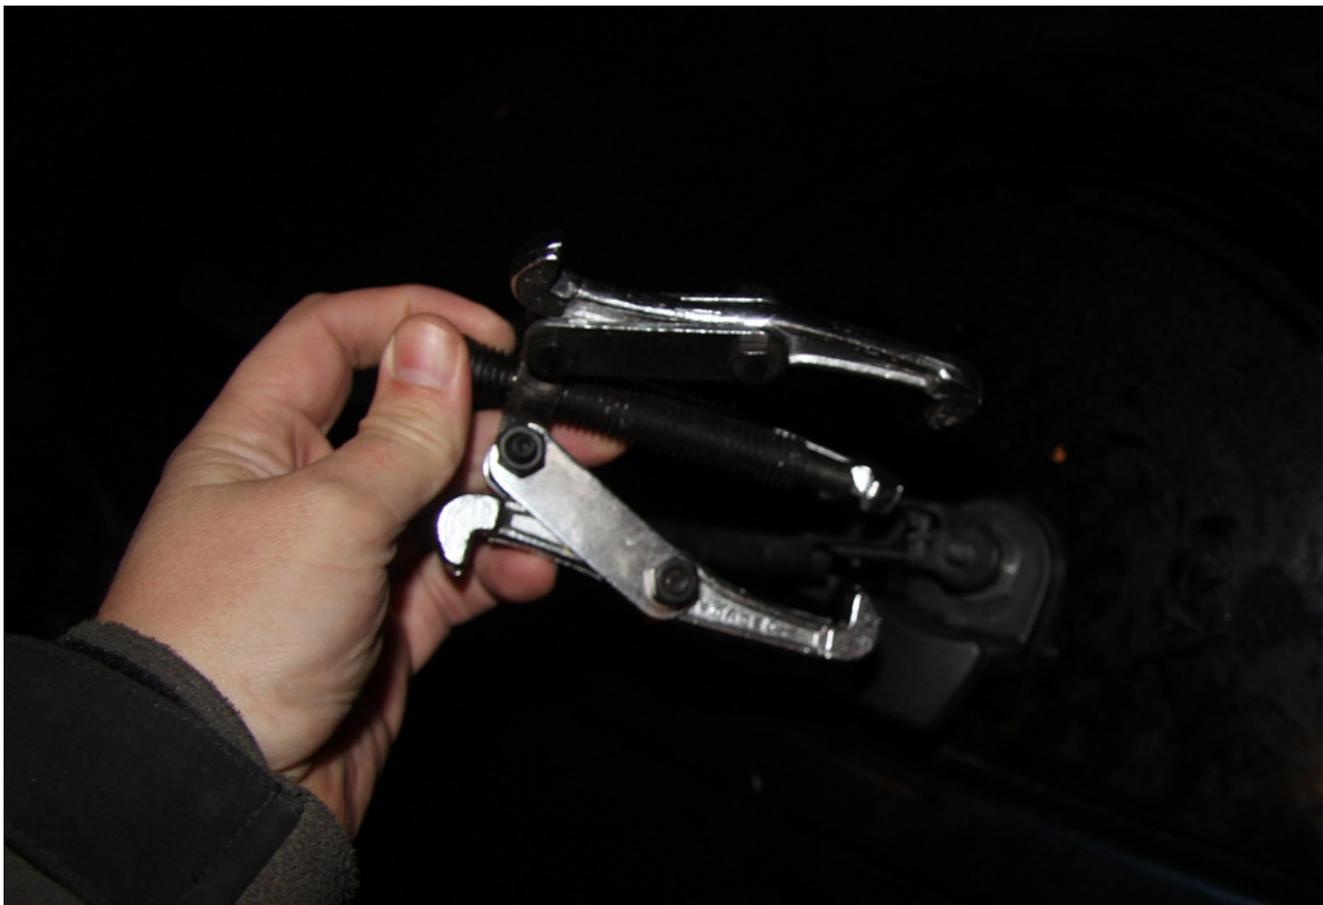
But first things' first; use a two or three legged ball bearing puller tool which slides in underneath the wiper and where the centre bolt you screw down can press against the centre of the wiper axle.

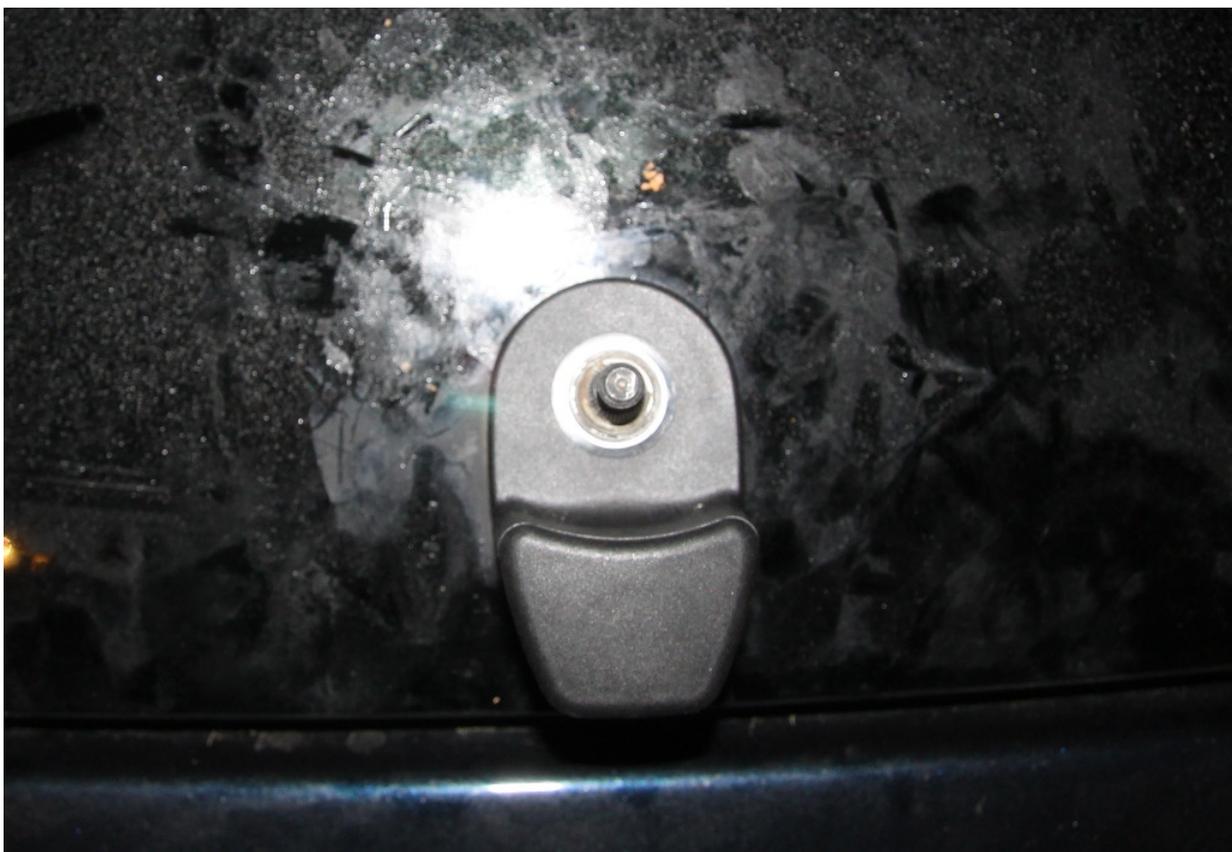
Now unscrew the 24mm nut with the open-ended spanner, as mentioned 2 pictures ago and you will have full access to the micro switch as follows

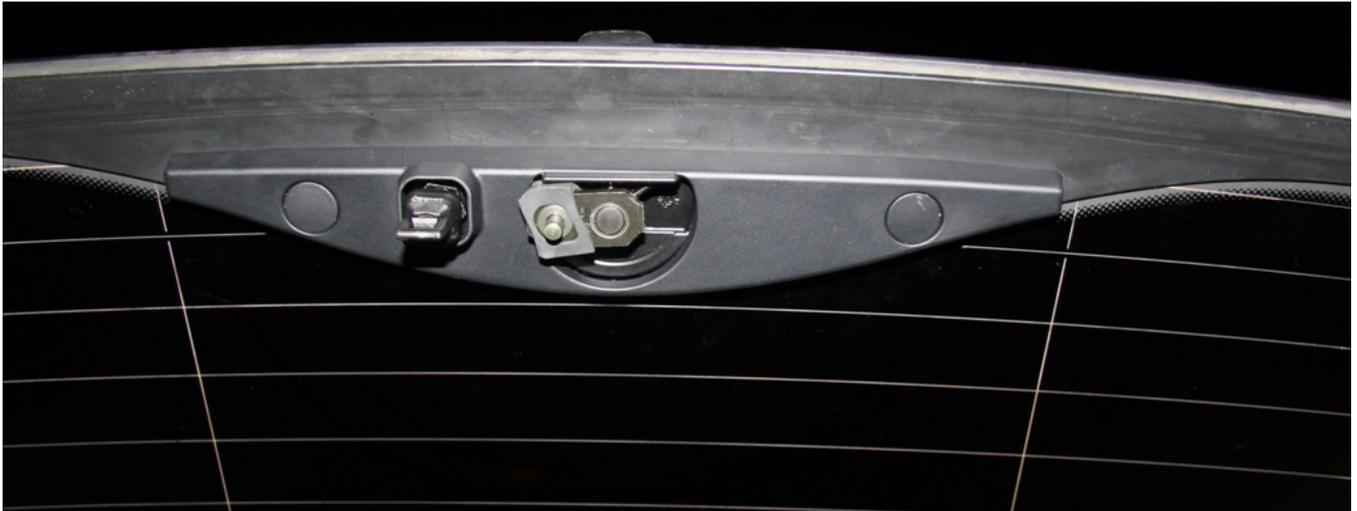
You can now simply pull the micro switch off the axle and in doing so, you will notice a wire which goes through the hole in the glass, so you will now need to open the glass to access the box on the inside of the glass.

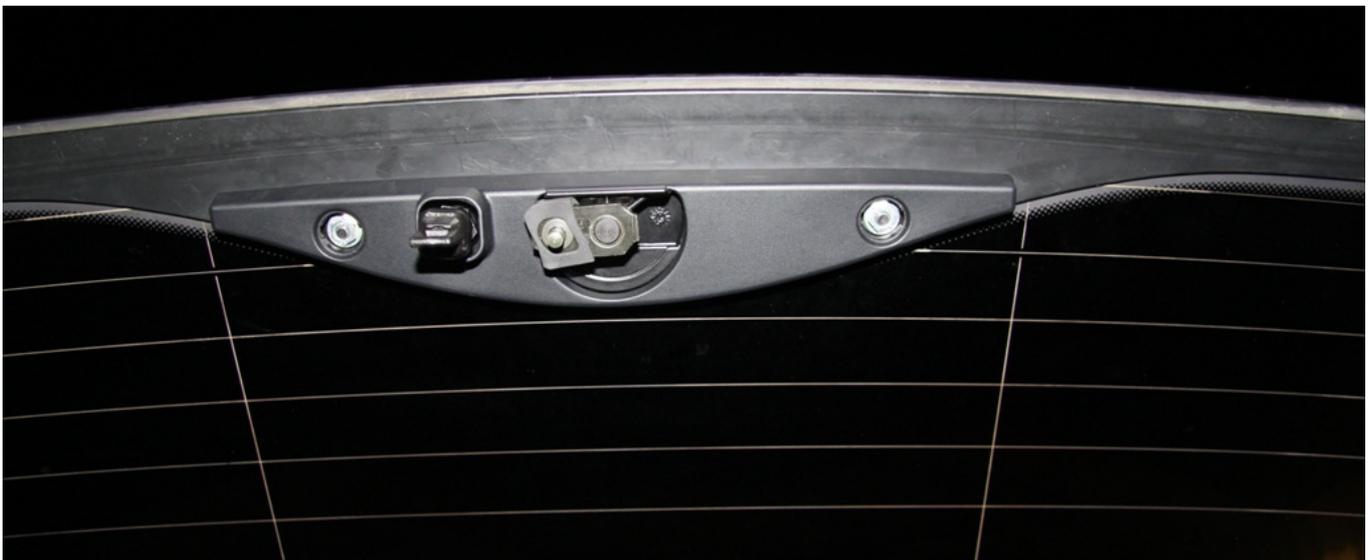
Use a fine screwdriver or knife to pry out the two black round covers so you can access the nuts below.

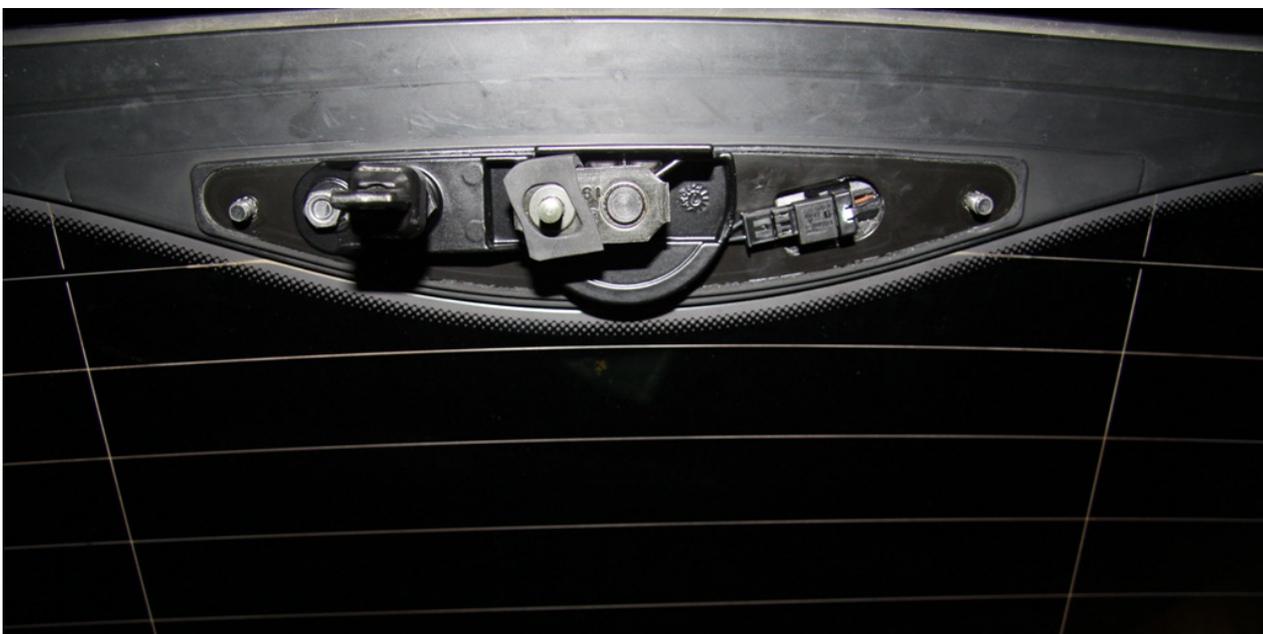
Now use the 10mm socket wrench to remove the two nuts and then gently take off the plastic cover.

Now you slide off the black electric connector and gently pull the axle assembly out of the hole in the glass. Throw away the defective micro switch, replace with the new micro switch. Reconnect the plug and put the axle assembly back in the hole. I forgot to take pictures of this but it is straightforward once you get to this step as all is loose and requires not tools or special knowledge to deal with.
