www.babybmw.net

Cruise Control retrofit on 2005 E87 118d

Right, here we go! This retrofit will be split into two halves, the physical fit and then the coding part.

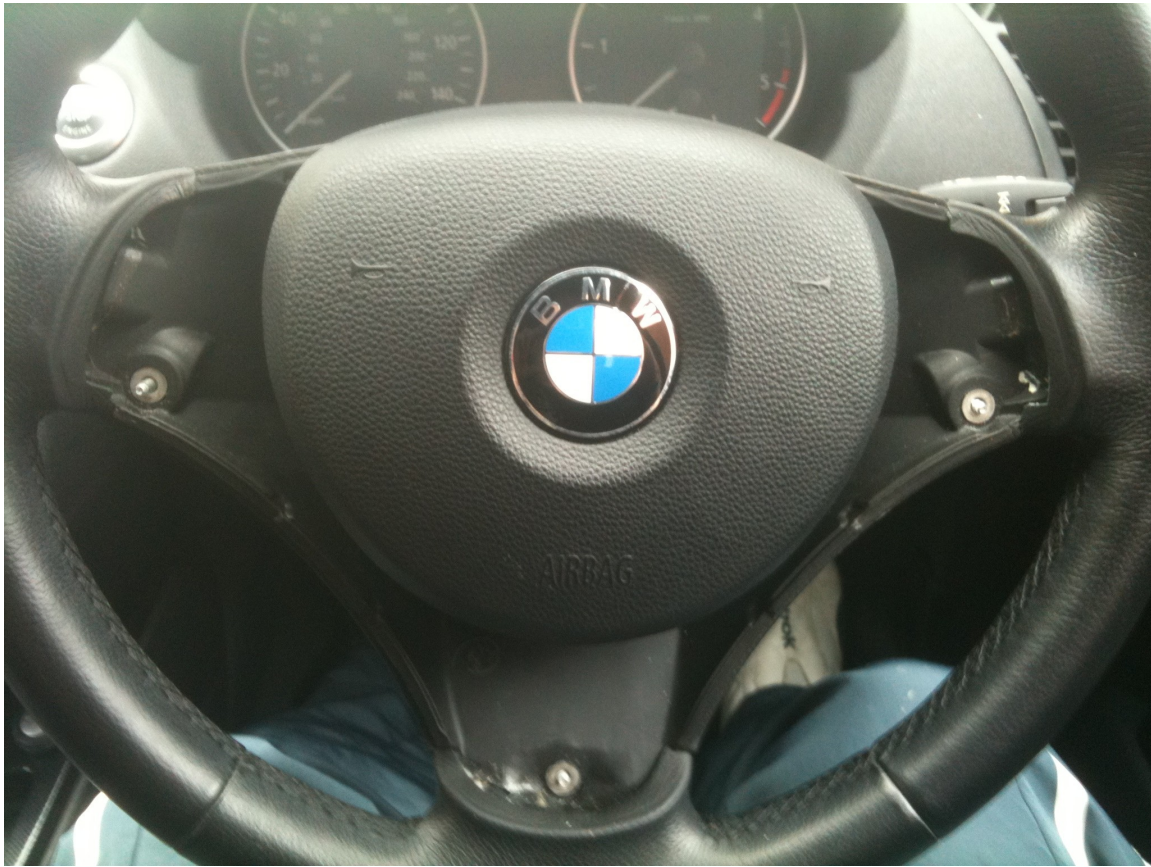
1. Ensure the car is parked on a flat, level surface with the front wheels pointing straight ahead and the steering wheel dead centred.
2. Disconnect the battery negative terminal using 10mm socket, and ensure it can't touch the battery once it has been disconnected. If you need a photo to show you how to do this, you are probably out of your depth and shouldn't be touching this retrofit!
3. Using a T10 Torx tool, remove the 3 bolts that secure the plastic trim to the steering wheel, they are located at the 3, 6 and 9 o'clock positions as you look at the steering wheel. Once the bolts are undone, if like me you have no MFSW you can remove the blank panel you can see the bolts in the picture below. If you have MFSW,

you need to do the next part with the panel bolts undone, but the panel still connected and loosely in place.

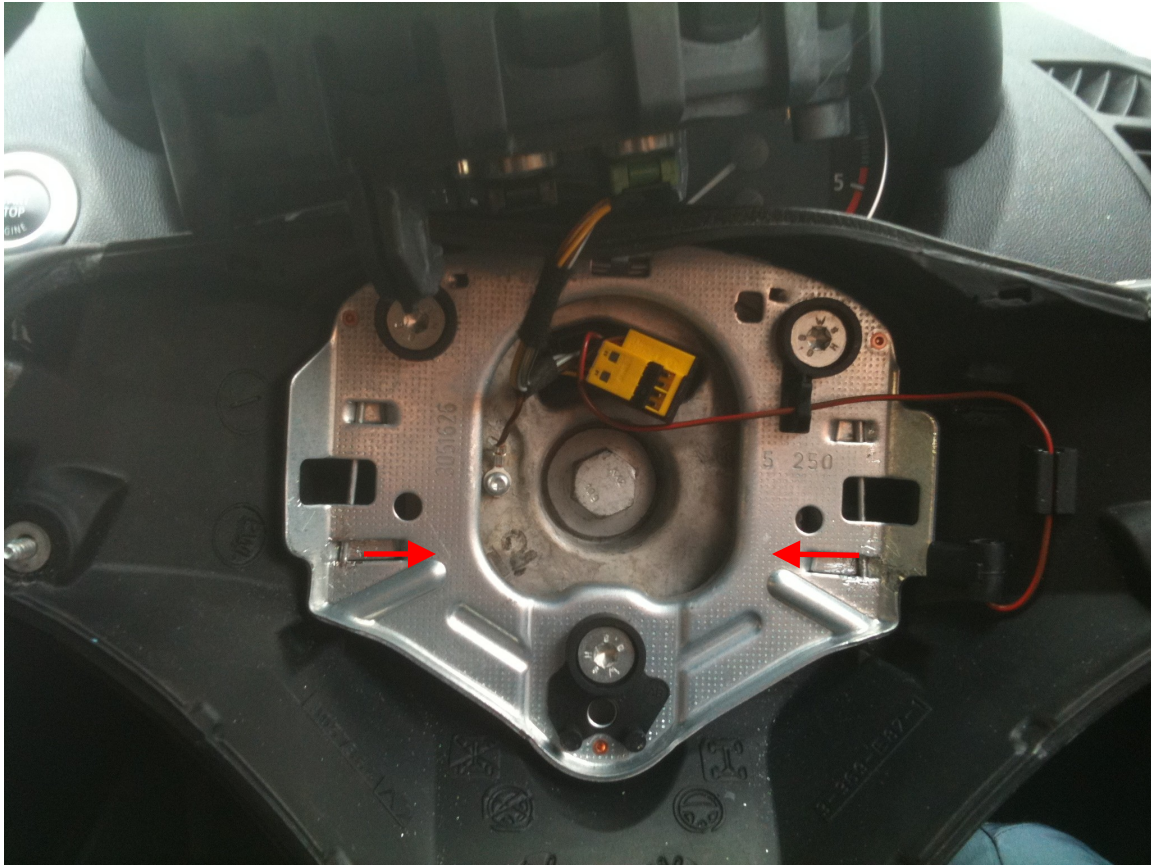
4. Next you must remove the airbag. To do this use the two small flat bladed screw drivers to simultaneously release the spring clips in both sides. In the picture below you can see the spring clips and the direction they must be moved to release the airbag.

You can see the scraping from my tools! You might find that you pop one side off but can get the other to release, that is why you need to try and do both at once.

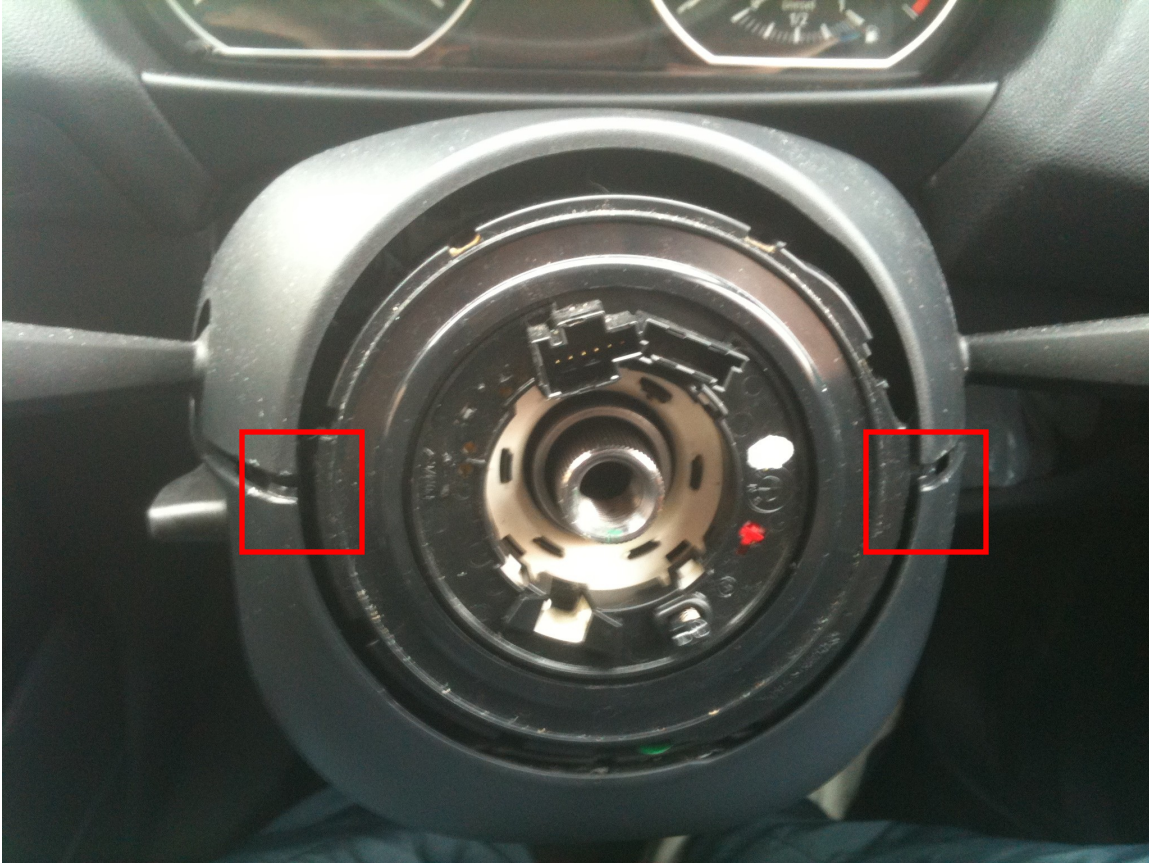
7. Remove the steering wheel and airbag and put them out of the way. Passengers seat footwell worked for me. Adjust the steering column to its lowest position and pull it towards you as far as it can go. The two red rectangles in the picture below show where the forward clips are, the clip is part of the upper shroud and it clips into the lower part. Using a small flat-blade, gently unclip the bottom part on both sides, You'll be looking at this now.

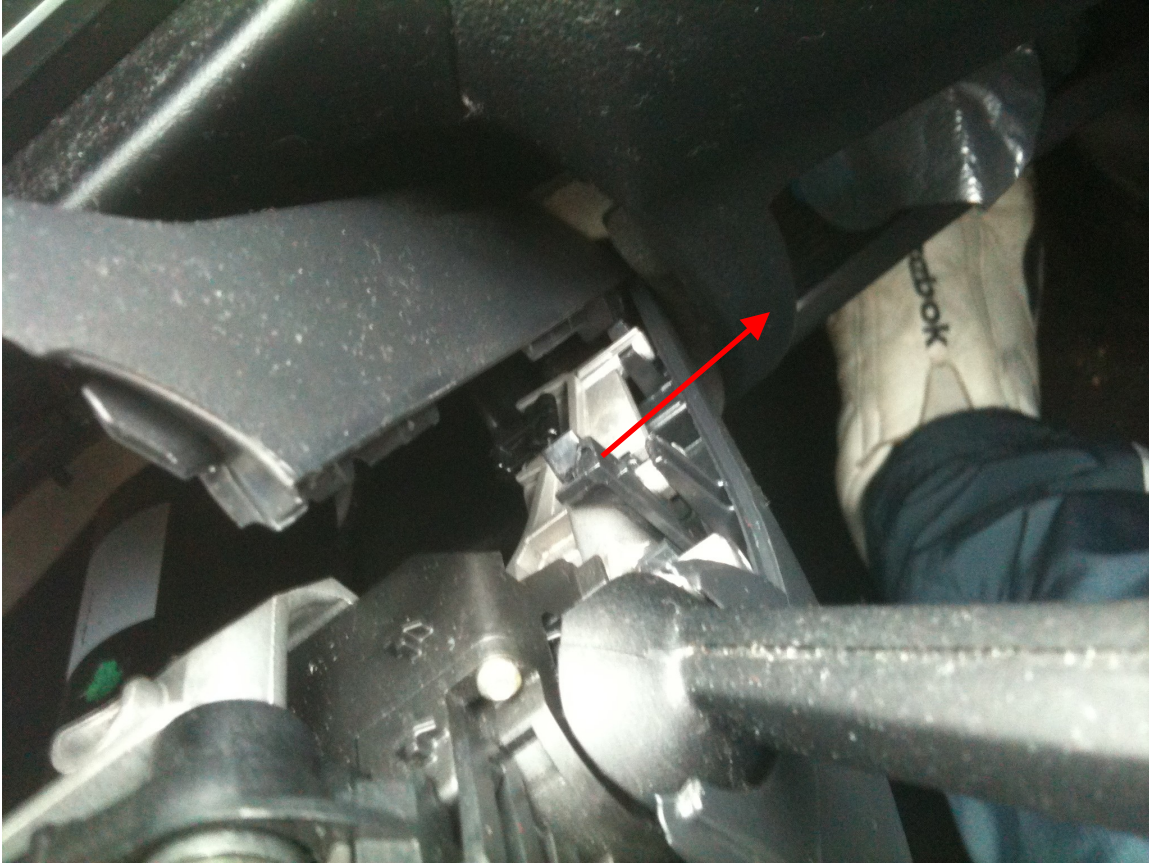
8. You should now be able to raise the top part of the shroud out of the way to expose the rear clips for the lower part. They release by pulling them outboard with gentle pressure in the direction of the arrows. This should allow you to remove the lower shroud.

n.b. You might have to move the steering column adjust lever out of the way to facilitate removal of the lower shroud!

11. Re-fit lower steering column shroud, ensure that the stalks on the L/H side sit flush in the cut out, also make sure the retaining clips shown in step 8 above are seated correctly and lined up before you push the shroud into place.

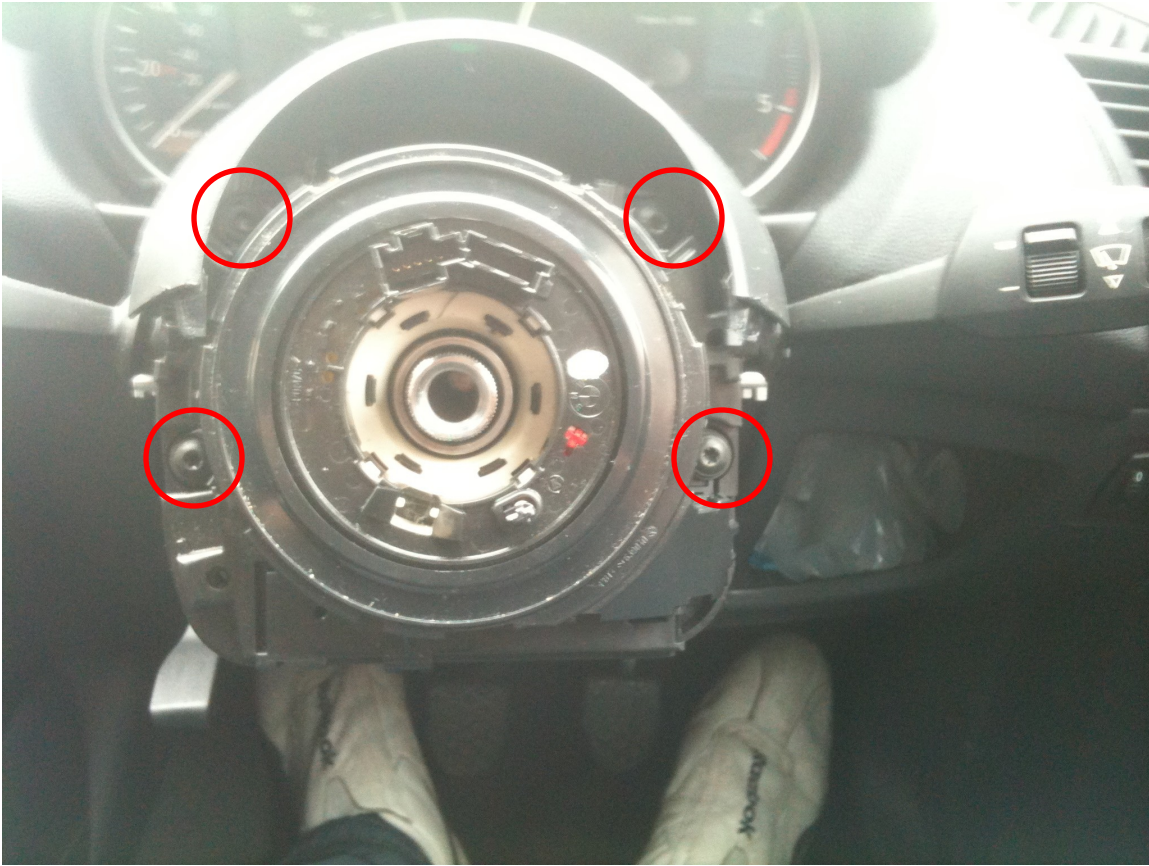
9. Once the lower shroud is removed, using a T20 Torx tool, remove the 4 bolts that secure the slipring to the steering column.

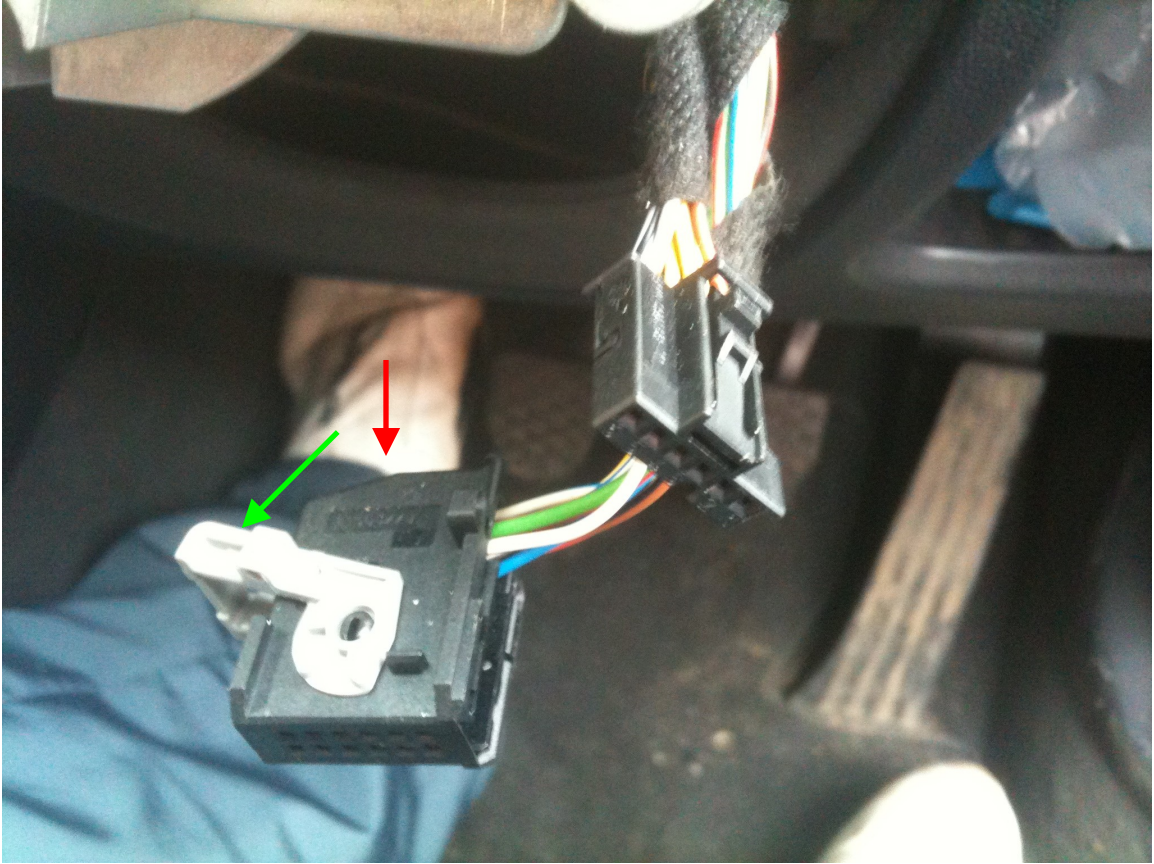
10. Disconnect the two looms that attach to the rear of the slip ring. One plug (the all black one) is a press to release clip, the other one shown below is removed as shown.

Press down and hold release catch as shown by direction of the red arrow.
Then slide grey lever in direction of green arrow.

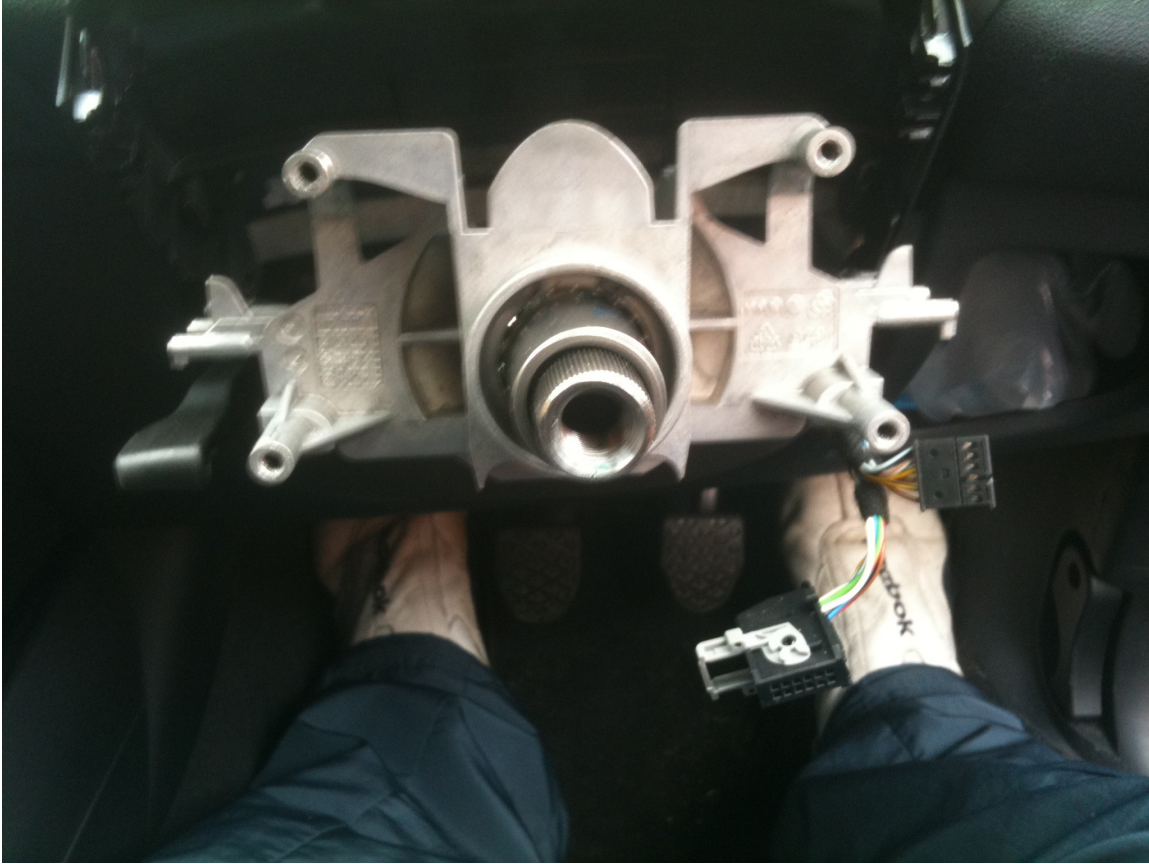
You will now have a bare column!

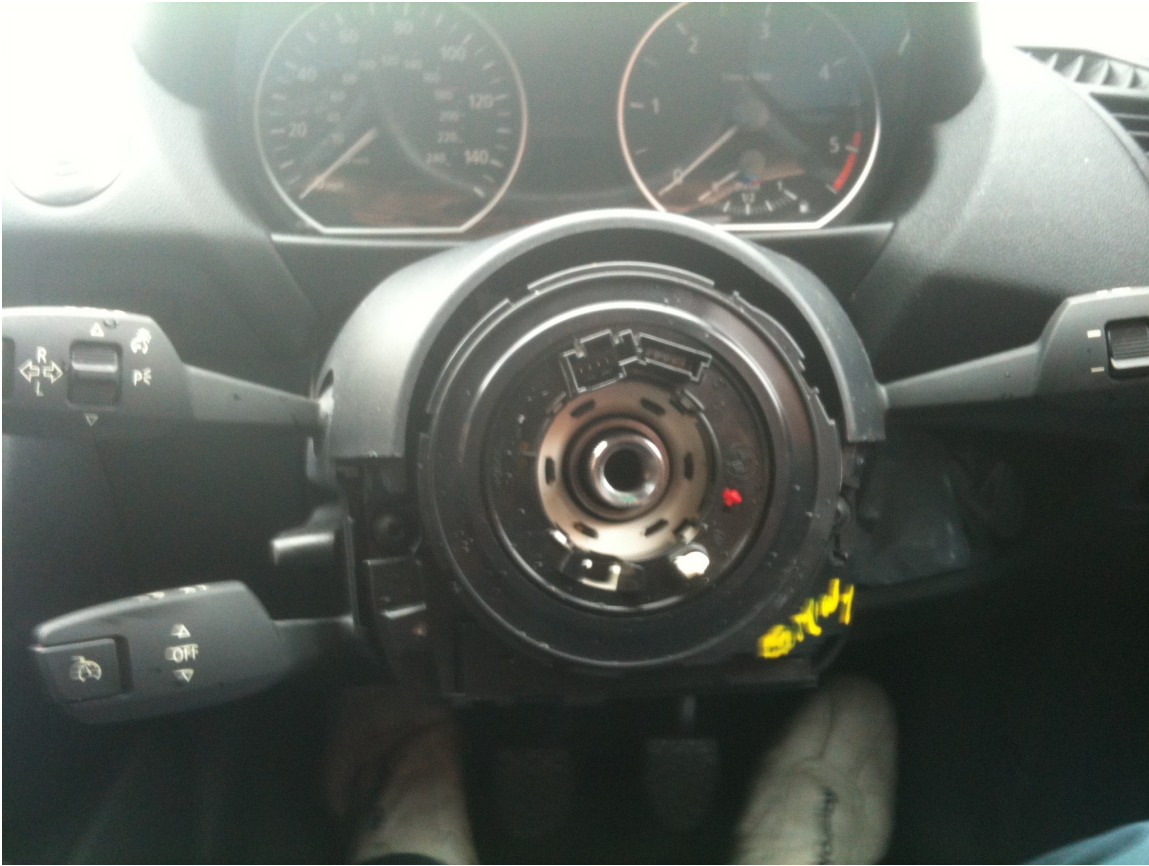
11. Fit new slip ring and reconnect both looms. If you are installing a new slip ring, remove the red coloured transit locking tab first!!!! Re-fit 4 T20 securing bolts

N.B. If you use a socket with a T20 head, you can easily apply too much pressure and shear the heads off the torx bolts! Ask me how I know! Fortunately my local dealer had one in stock!

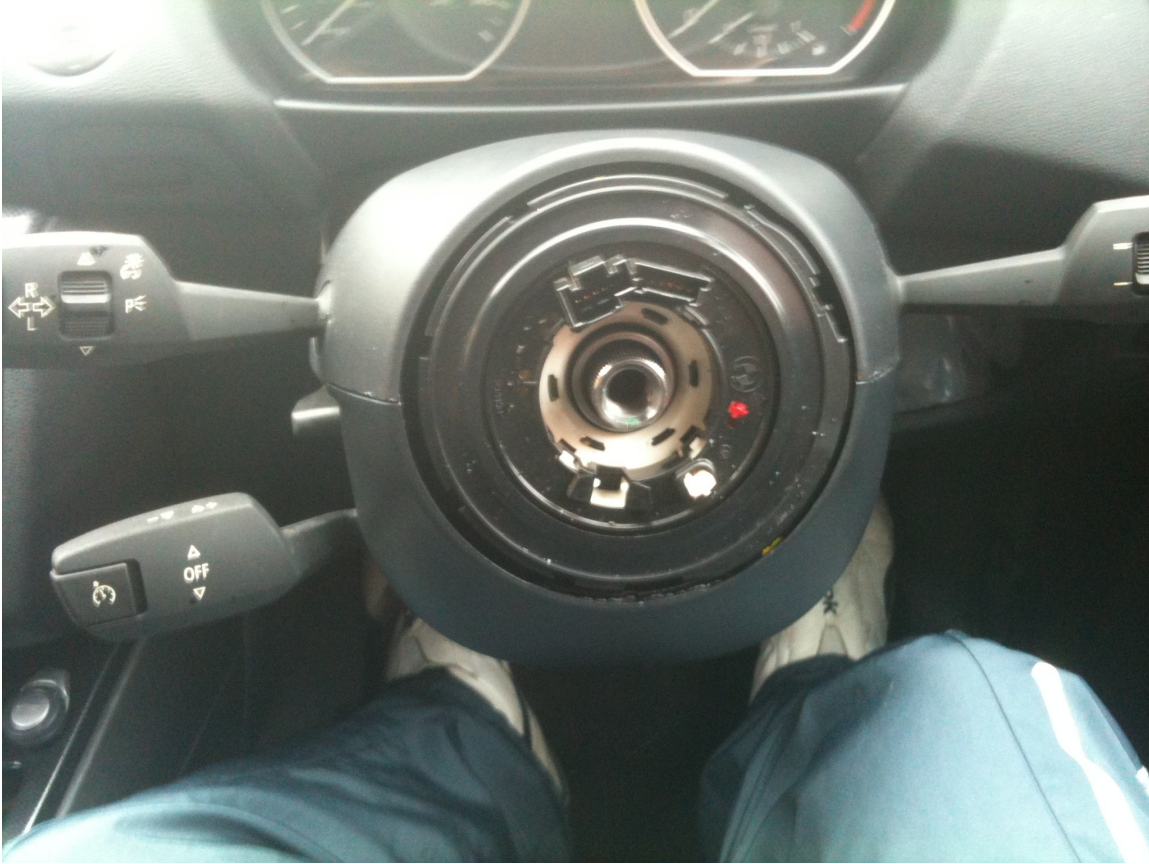
12. Attach the upper shroud to its lower counterpart and ensure securing clips all 'click' into place.

Almost done!

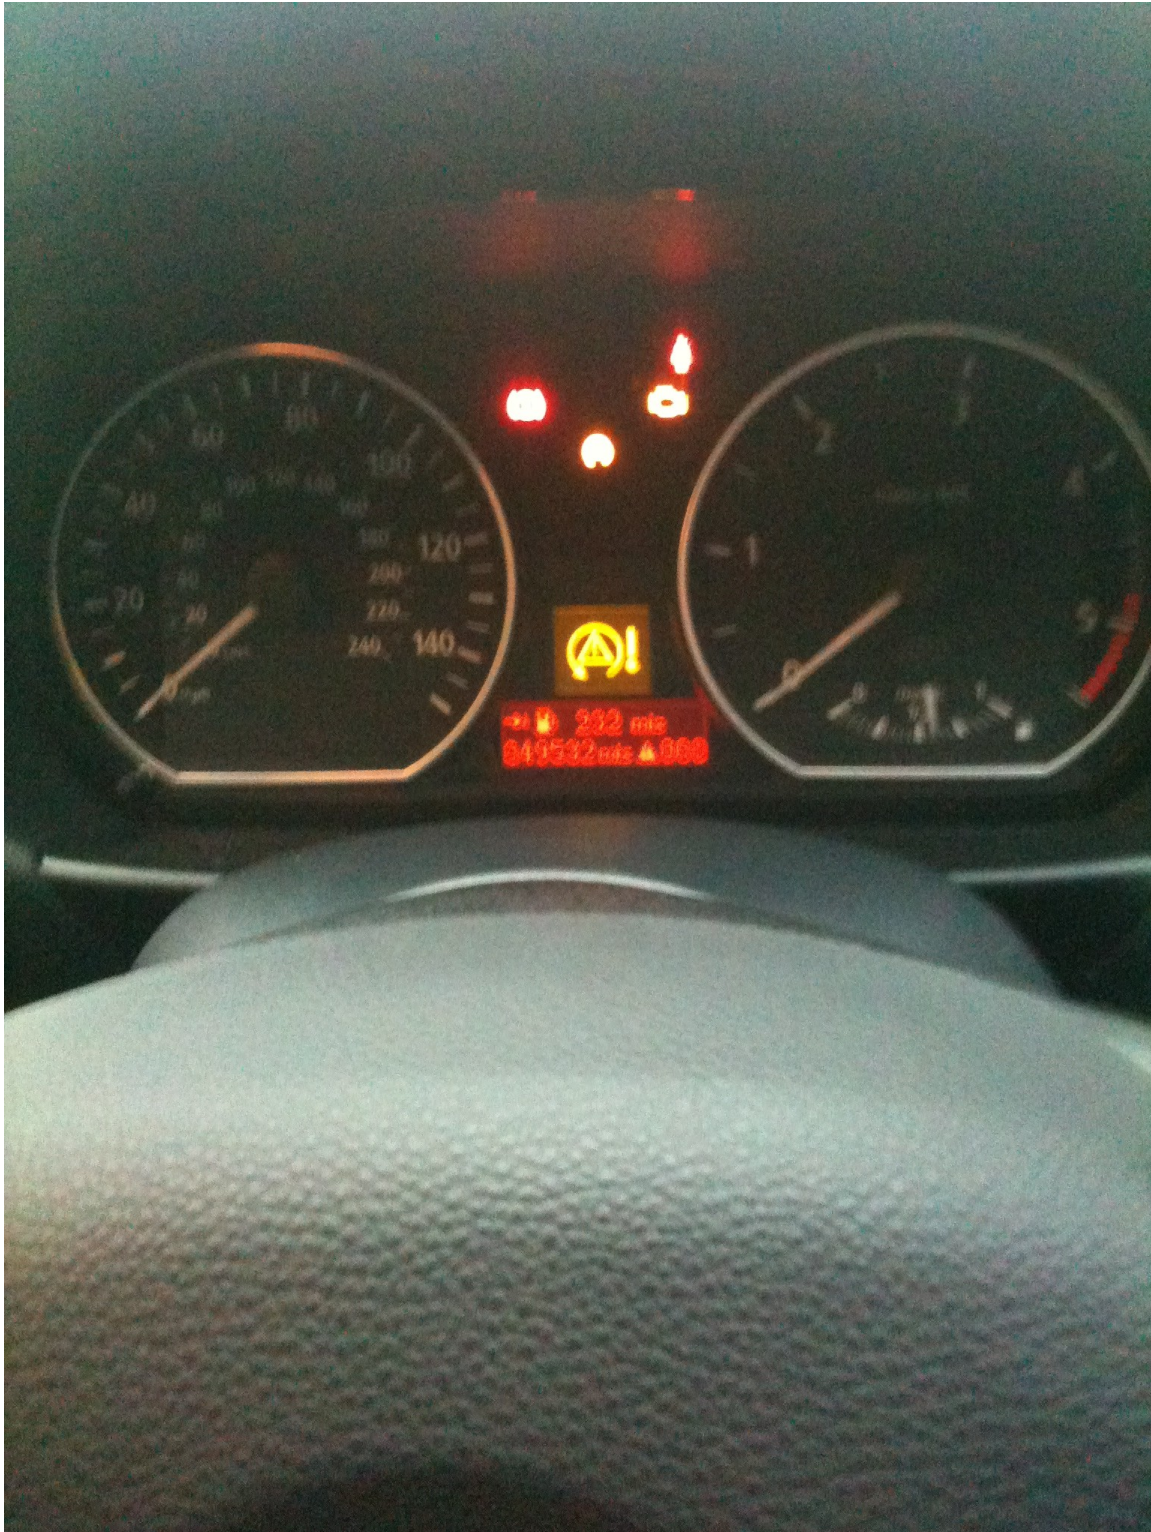
16. Gently push airbag back into its housing, ensuring it engages the retaining spring clips on both sides.
17. Reconnect battery negative terminal. On switching on ignition your dash board will look like this.

This is because cruise control needs to be coded to the car. At this point you can either take it to the dealers or an autologic specialist for them to do it, or if you are feeling brave, code the retrofit yourself like I did! Your car is ok to drive at this point, but you will have no ABS or DTC functions as indicated by the dashboard.
