Replacing Plastic Window Guides (Coupe)

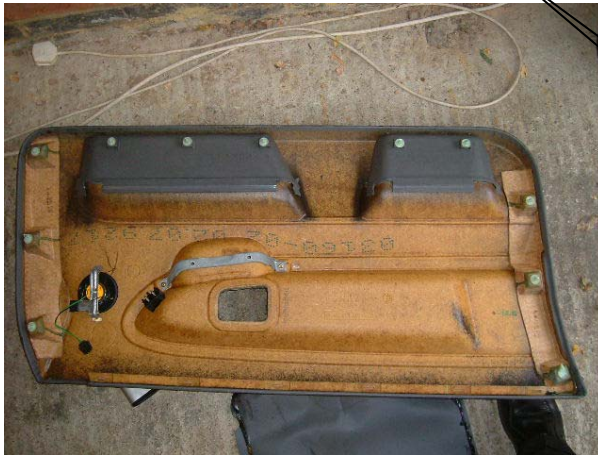
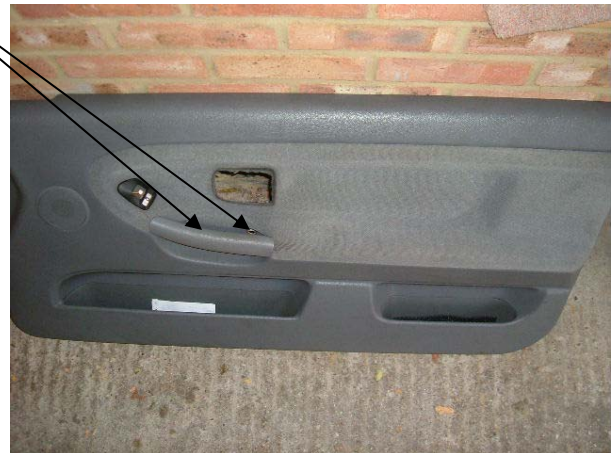
Here's the door card out, with the holes indicated.

To remove the door card, you need to slide forward the plastic trim that fits around the door handle, prise out the 2 plastic covers in the grab handle area and undo the 2 torx bolts, then pull the door card off the door, starting at the bottom. Pull the bottom of the door trim from the side pocket bits, then gently pull the sides away and lastly the top. Be careful with the top, as the clips here are metal and they fit into the hardboard of the door trim, so if you are too rough you may damage the door card (not the end of the world, as a repair kit is available from BMW to patch up the holes in the hardboard so the clips can clip in again).

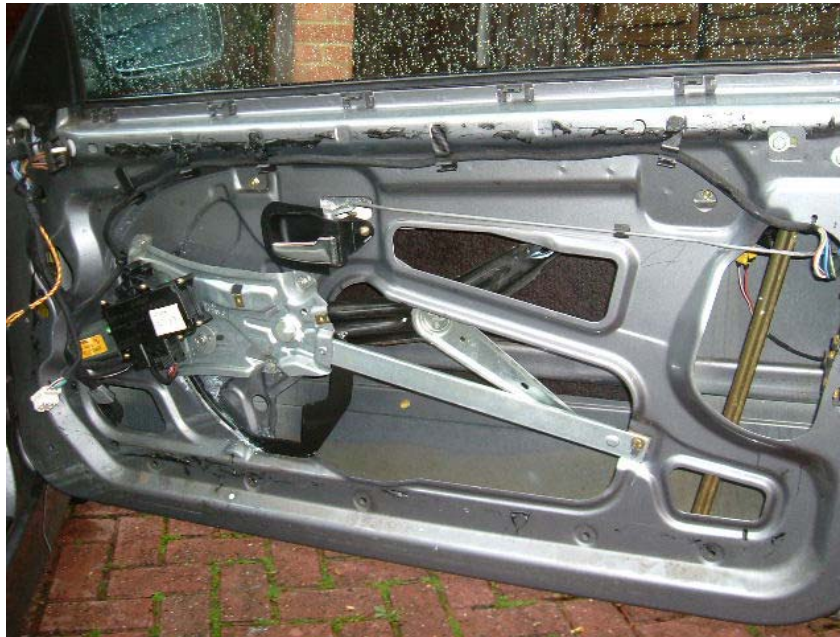
The picture above is what it looks like with the window up. The black unit attached to the large metal plate is the window motor.

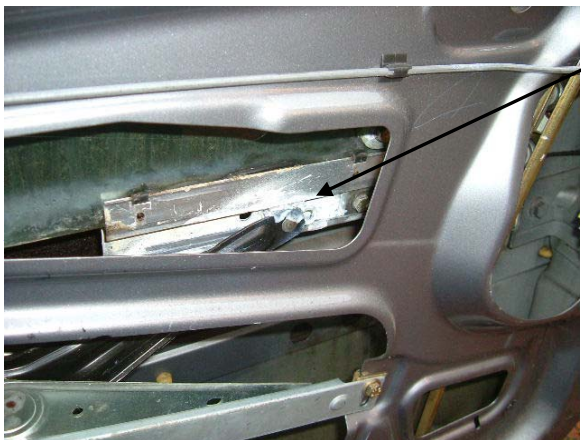
Runner nearest the door latch

If you wind the window down, you will be able to see the runners

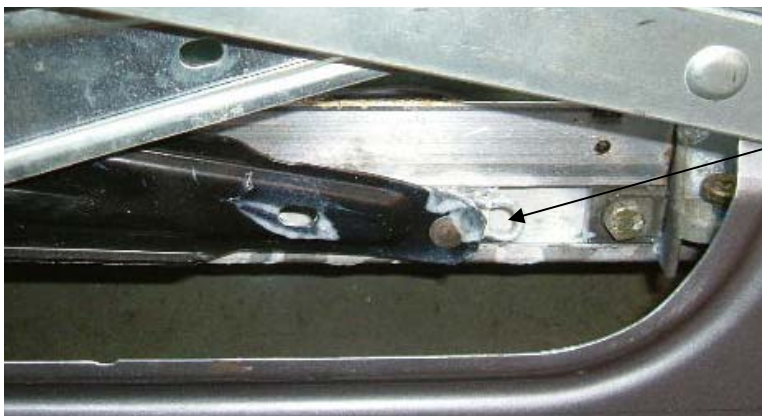
**Retaining
Clip**

So, here's how you get them out....

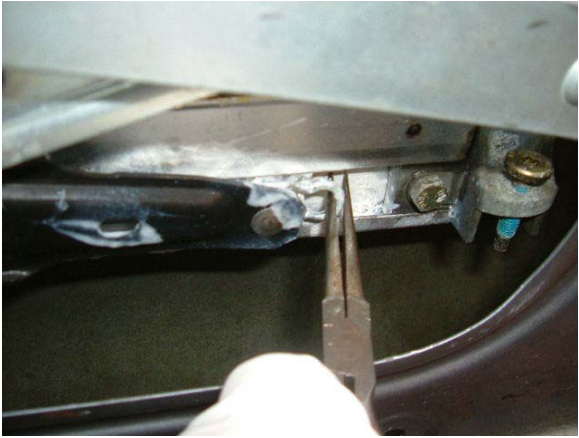
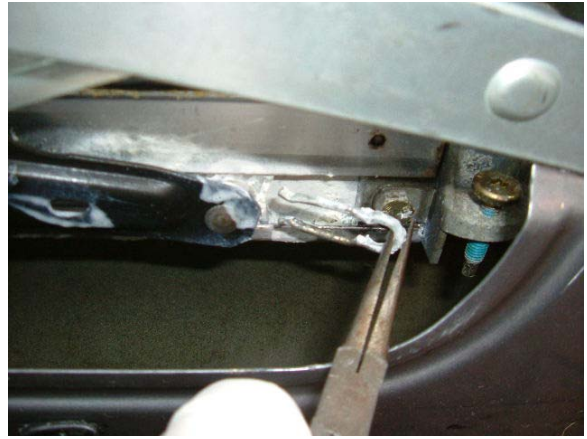
Use a pair of pliers to pull the retaining clip off of the plastic guide.....like so:

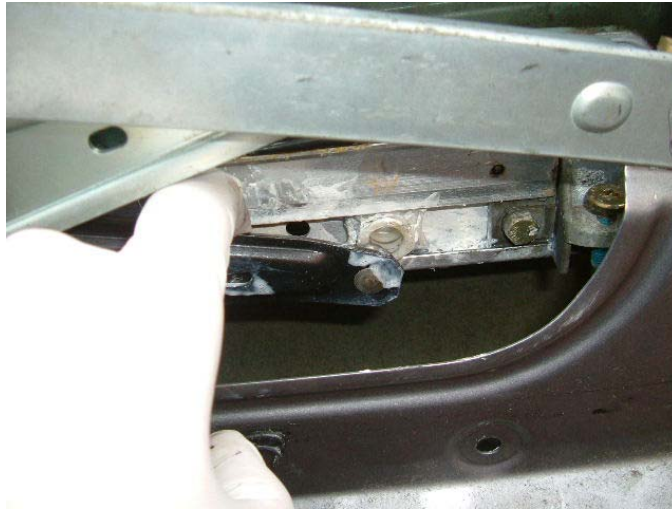
Now pull the window mechanism arm out just enough to remove the ball end from the white plastic guide. Don't pull too much or you may bend the arm.

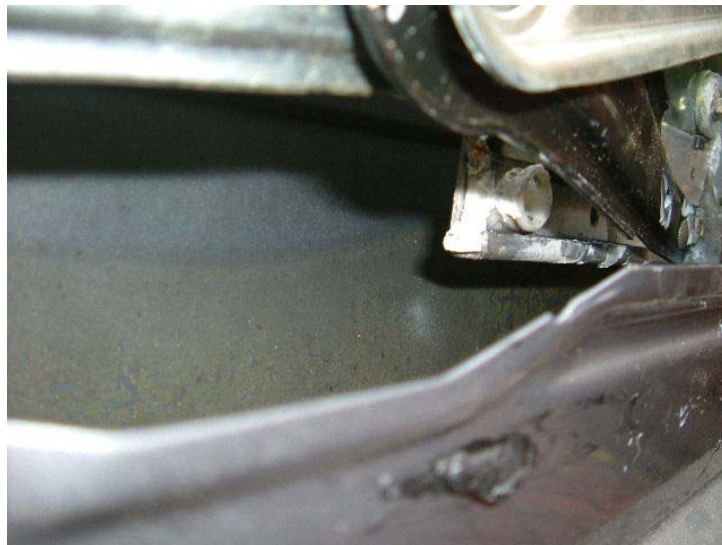
With the arm out, you can then slide the plastic guide towards the middle of the window so it comes out of the end of the runner (pretty obvious which way to push the guide, as the other end of the runner is blocked by a large nut!).

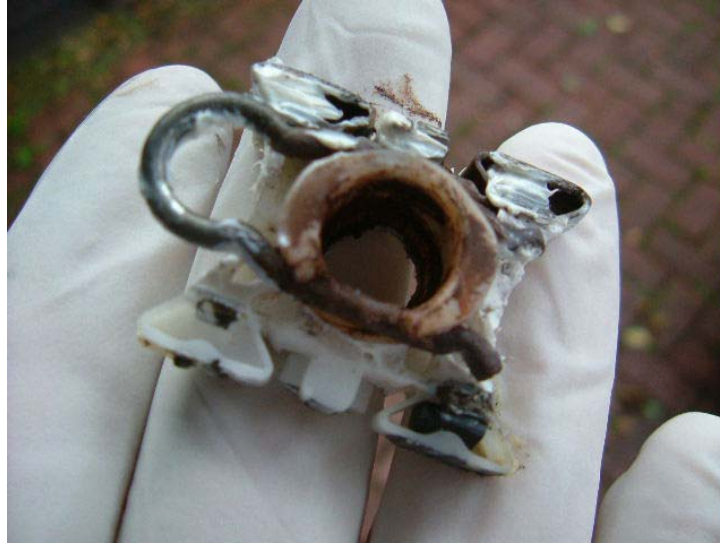
So, my window has been making funny clonking noises since as long as I care to remember. Whipped the door card off one day to discover one of the plastic window guides was partly broken, allowing the window lifting mechanism to bang in and out when the window was raised or lowered.

This is why mine was making a funny noise.....the collar bit has broken, mishapen and the retaining clip has also given up!

Ok, new clips look nice huh? Take off the retaining clip, slide the new guide into place (may need a bit of grease to help this), pull the arm out slightly to get it lined up with the hole in the guide, then push it home. It will be a bit stiffer to get the arm into the new clip...but that's a good thing! I found if you grip the underside of the window around the metal bracket and also the arm, you can squeeze the arm into the guide without risk of bending anything.

Once that's in, put the retaining clip back on (using the pliers again).

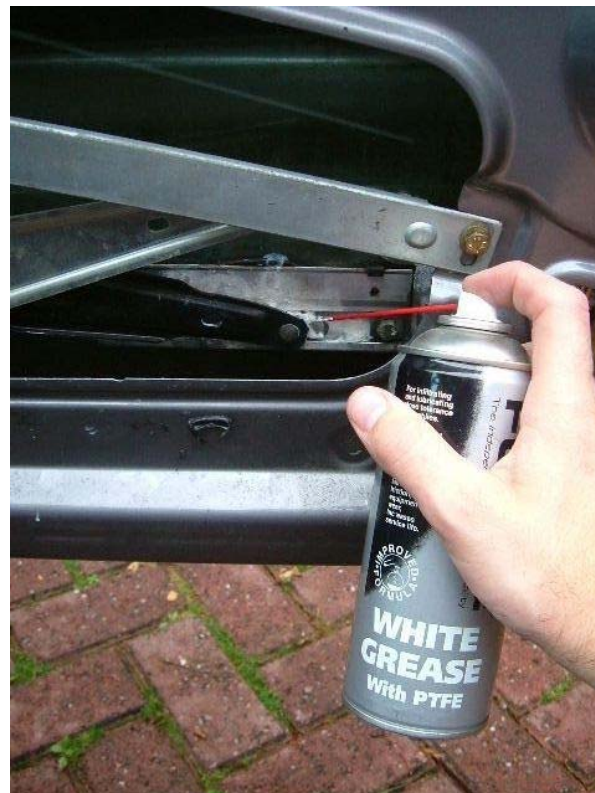
Then grease up the runners and guides to make sure it all moves with relative ease.

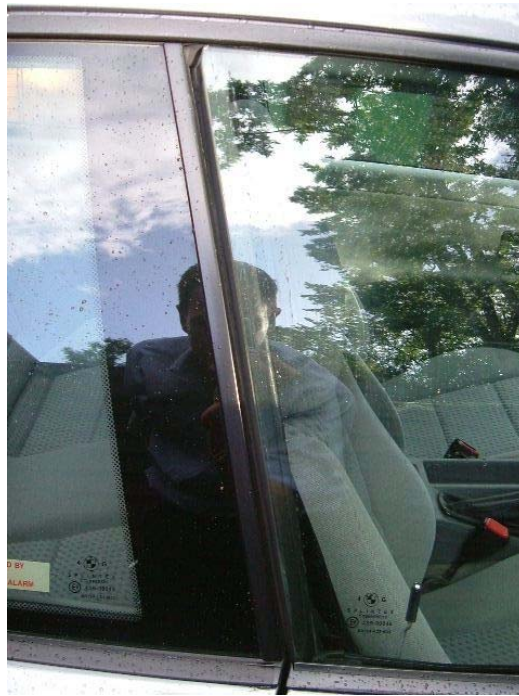
Once you have done both clips, open and close the door to make sure the window is still aligned properly, as it can be tilted slightly forward if the plastic guides were worn.

The gap should be the same all the way down the side of the window glass, and the angled bit by the wing mirror should also be the same gap all the way along the length.

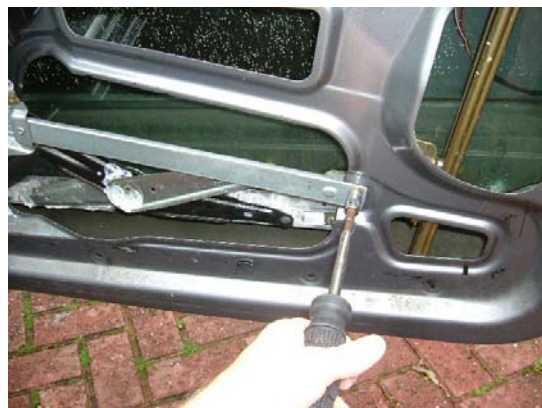
If the gap is wrong, you can adjust it by undoing the nut shown below and moving the bar. Moving the bar up will move the window glass nearer to the centre pillar of the car, and moving the bar down will move the glass away from it. Only small adjustments (if any) will be needed.
